Manhole Inspection Summary

Manhole # S21EE1007MH

Location Address: **2000 41ST ST**

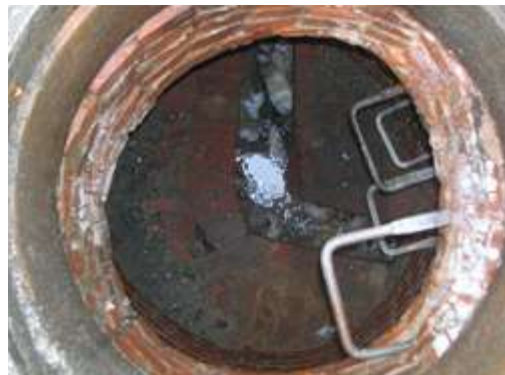
Top View

Evidence of surcharge - Bench debris.
Channel debris.

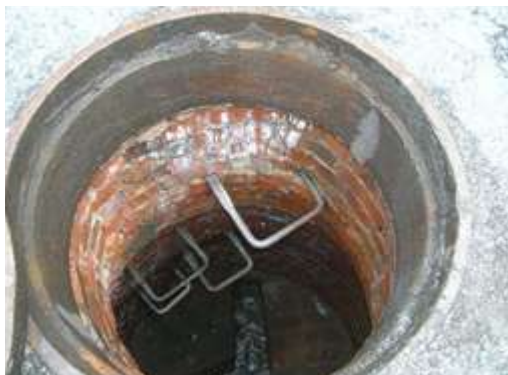
Defect

Frame leaks. Adjustment and Corbel
deterioration and infiltration. Barrel
infiltration - other side.

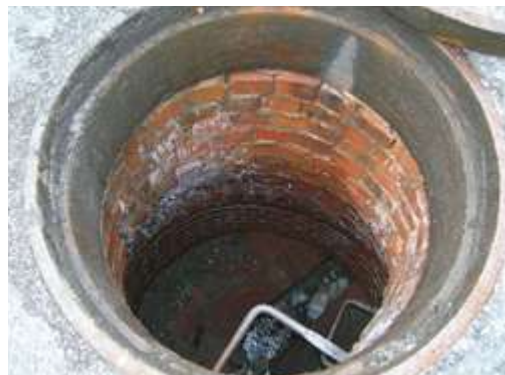
Defect

Frame leaks. Adjustment and Corbel
deterioration and infiltration. Barrel
infiltration.

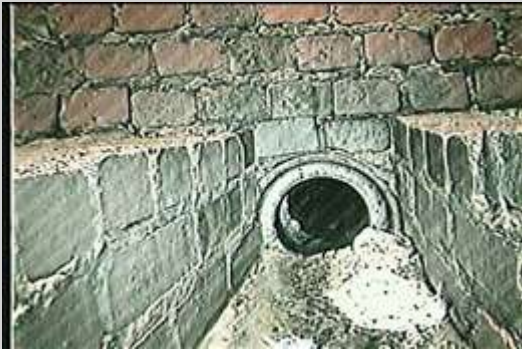
6 in. Circular Gravity Sewer Pipe Out @ 12 O'Clock

Barrel deterioration and infiltration. Channel deterioration.

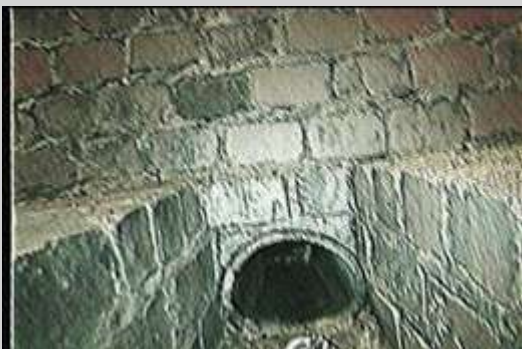
6 in. Circular Gravity Sewer Pipe In @ 4 O'Clock

Barrel deterioration and infiltration. Channel deterioration.
